Sewer Scope Inspection Report

NAME: Shauna Iseri	EMAIL: shaunaiseri@gmail.com	PHONE: (208) 985-8262
DATE: March 9, 2024	PO: RL-332-24	BUILDING AGE: 99 years
BUILDING STYLE: Single Family Residence	ADDRESS: 7236 Ledroit Ct SW Seattle, WA 98136	ATTENDEES: Agent, Inspector
WEATHER: Overcast	REALTOR: Sarah Georger Clark	EMAIL: Sarahgc@cloudcityhomes.com
INSPECTION TYPE: Sewer	INSPECTION BUNDLE: Inspection and Report

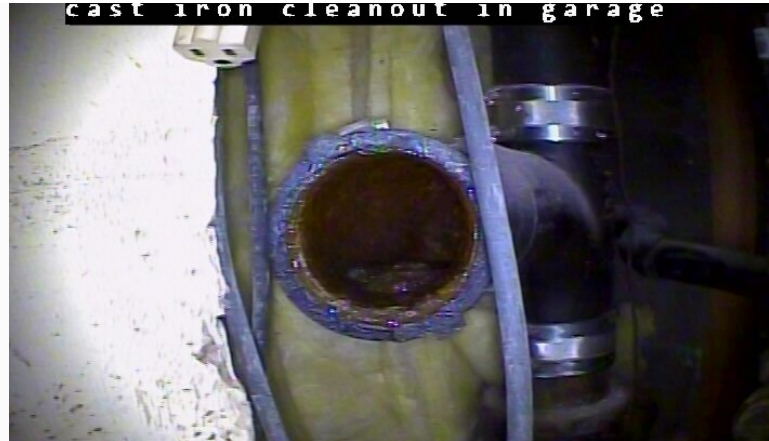
Sewer Access #1

TYPE: Interior Cleanout

MATERIALS: Cast Iron

SURFACE MATERIAL: Garage

CONDITIONS: Appears Functional

RECOMMENDATIONS: No recommended maintenance, repair or replacement at this time.

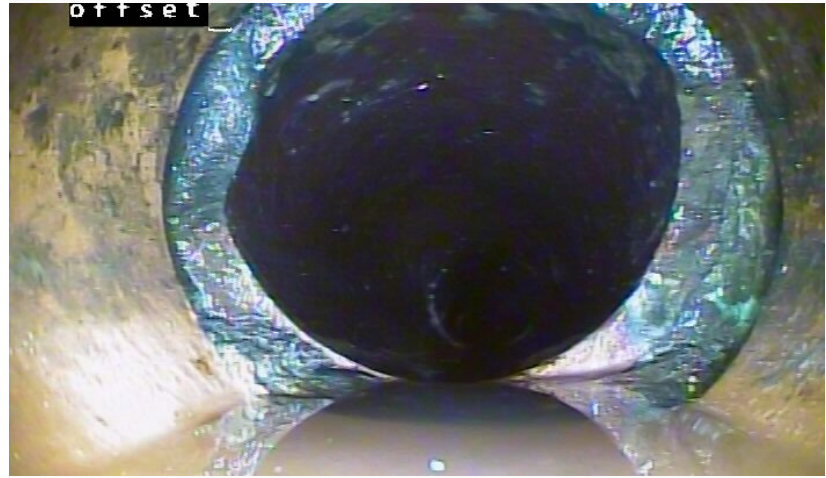
Condition #1

COMMENTS: The sewer line is currently functioning. There are a few offsets present, but the water is making it past them and flowing to the sewer main. Due to the age and the material, I would monitor the line through a follow up inspection in the future to make sure it is still functioning.

CONDITION: Offset

PIPE MATERIALS: Clay

**DISTANCE TO
CONDITION FROM
ENTRY POINT:** 1' from
garage
door

CONDITION DEPTH: 1'4"

**CONDITION
LOCATION:** Driveway

RECOMMENDATIONS: Recommend monitoring of the condition item/s through a follow up inspection to identify significant changes in the condition items observed during the side sewer inspection.

**RETURN
FREQUENCY:** (1 to 3 years) Conduct a return inspection in 1 to 3 years to observe significant changes in the condition items listed in the condition portion of this inspection report.

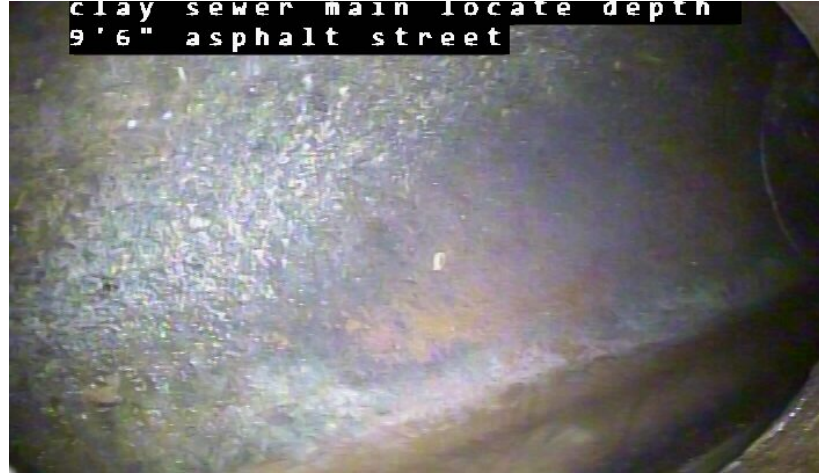
Sewer Main

CONNECTION MATERIAL:	Clay	CONNECTION LOCATION:	Street
CONNECTION LOCATION SURFACE MATERIAL:	Asphalt	DEPTH:	9'6"
CONNECTION CONDITION:	None	MARKER:	None

COMMENTS: No issues observed with the sewer main connection.

RECOMMENDATIONS: No recommended maintenance repair or replacement at this time.

RETURN INSPECTION FREQUENCY: (5 years) Conduct a return inspection in 5 years due to the satisfactory condition and functionality of this side sewer pipe at the time of the side sewer inspection.
