Report: 3213 - 3950 se arroyo dr seattle

Confidential Inspection Report

3950 SE Arroyo DR

November 6, 2018

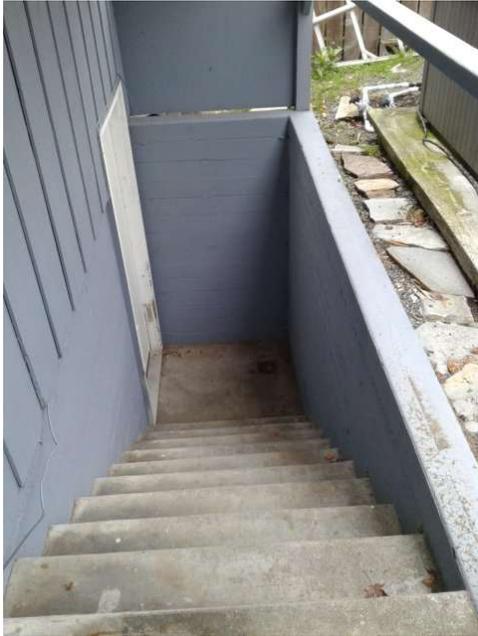
MINOR REPAIR: The stairway down to the basement is missing a handrail, creating a safety hazard. Recommend a licensed and bonded contractor make repairs to meet today's building standards.

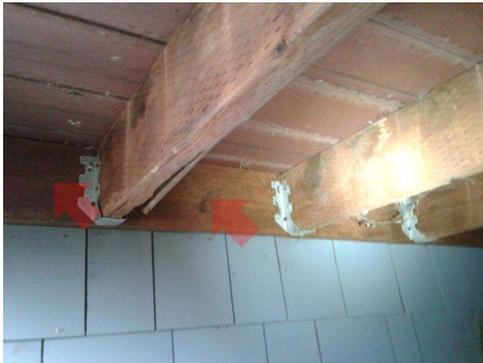
MINOR REPAIR: The deck ledger board is not attached with ledger bolts and washers. This type of construction method is not considered structurally sound by today's standards as the deck is not supported for lateral movements Recommend a licensed and bonded contractor make repairs to meet today's building standards.

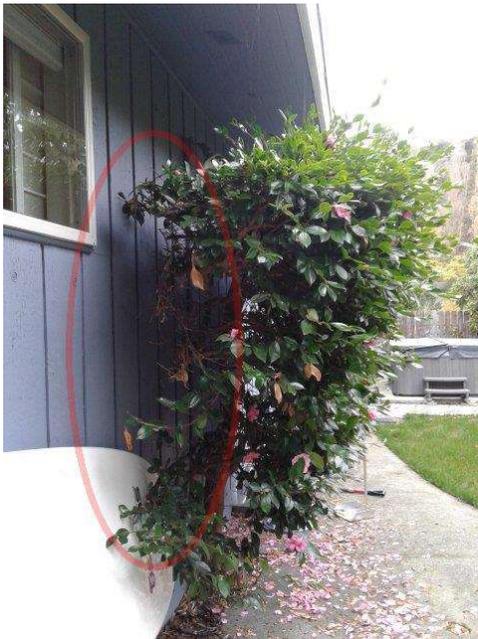
Landscaped 12/18

DEFERRED MAINTENANCE: The vegetation is in contact with the siding in numerous locations. This condition could potentially cause water damage/wood rot at the point of contact. The area of concern is located: on the East side, backyard. Recommend a licensed and bonded contractor make repairs as needed.

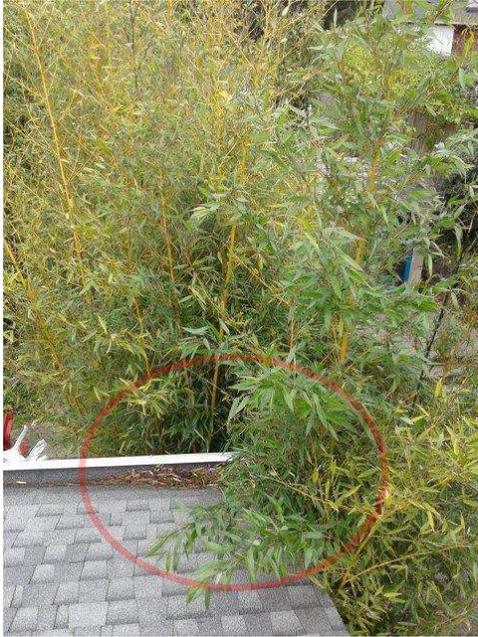
Landscaped 12/18

DEFERRED MAINTENANCE: The vegetation is in contact with the siding in numerous locations. This condition could potentially cause water damage/wood rot at the point of contact. The area of concern is located: on the Southeast corner of the house. Recommend a licensed and bonded contractor make repairs as needed.

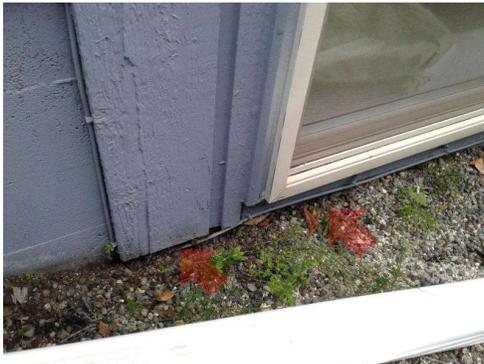
DEFERRED MAINTENANCE: Lower soil below siding. This condition could potentially lead to wood rot and/or moisture damage to the siding and structurally framing. Grade should be 6 inches below any wood materials The area of concern is located: on the North side. Recommend a licensed and bonded contractor make repairs as needed.

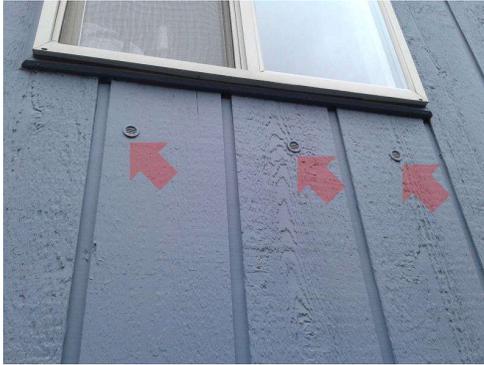
MINOR REPAIR: The walls appear to have had insulation added in the past, there are exterior penetrations are capped with vent covers. The exterior siding does not require ventilation and creates a condition for potential heat loss. Consider removing the vents and sealing the openings.

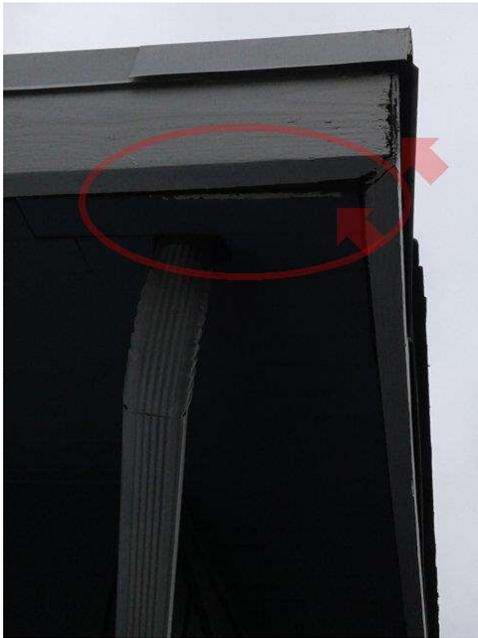
MINOR REPAIR: There are gaps in the soffits, fascia, trim, etc large enough for rodent entry. The area of repair is the NE corner of the house.

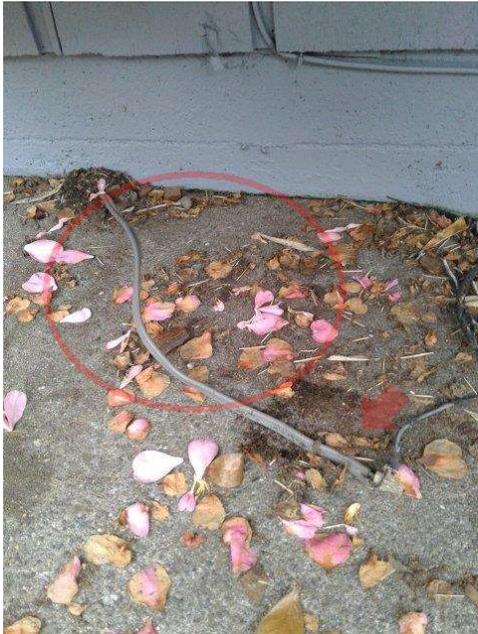
Repaired 12/18

MINOR REPAIR: There is exposed electrical wiring on the exterior back patio. The inspector tested the electrical with a voltage tester and did not find current through the outlet. However, this is a potentially unsafe condition. Recommend a licensed and bonded electrician make repairs to meet today's electrical standards.

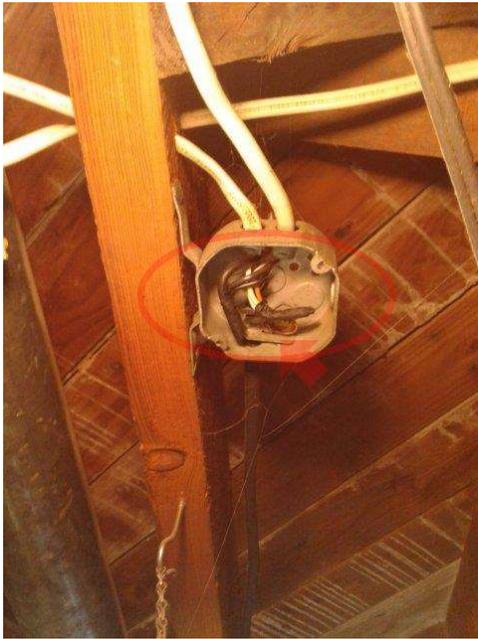
MINOR REPAIR: There is a junction box missing a cover plate. The area of repair is: in the unfinished basement. Recommend a licensed and bonded electrician make repairs to meet today's electrical standards.

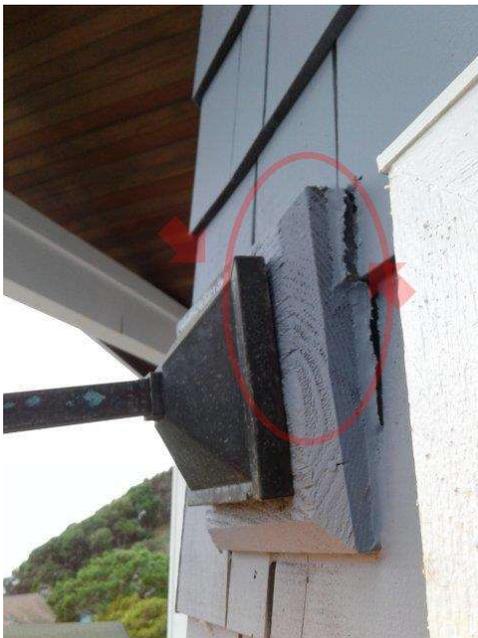
MINOR REPAIR: The light fixture at the front entrance is loose, repair/re-secure as needed.

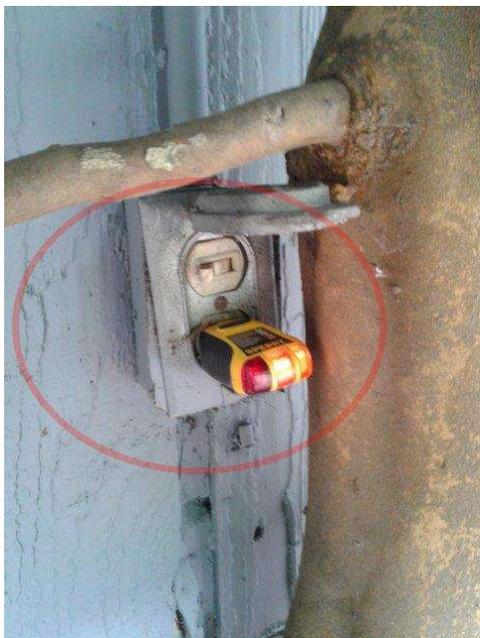
MINOR REPAIR: Exterior Outlet defects were noted: As per today's electrical standards, The exterior outlets are not rated for use on the exterior. The exterior outlets do not have a protective cover designed to keep out water.

The electrical outlet(s) are not GFCI protected at: Exterior. Recommend a licensed and bonded electrician make repairs to meet today's electrical safety standards.

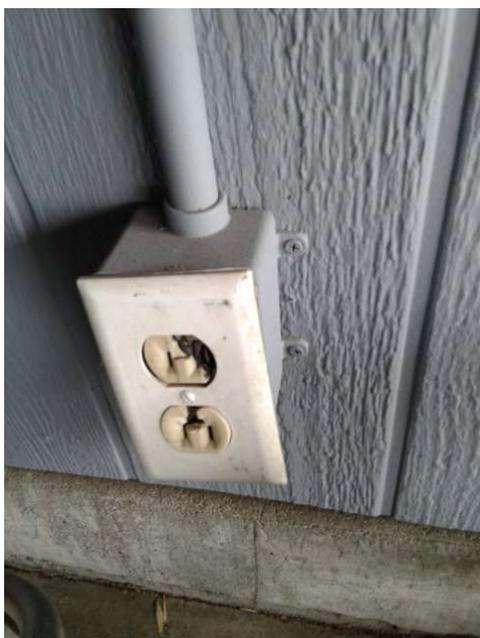
Repaired 12/18

MINOR REPAIR: Garage outlet defects noted: As per today's electrical standards, The electrical outlet(s) are not GFCI protected at: The carport. The carport electrical outlet is damaged, creating a safety hazard. Recommend a licensed and bonded electrician make repairs to meet today's electrical safety standards.

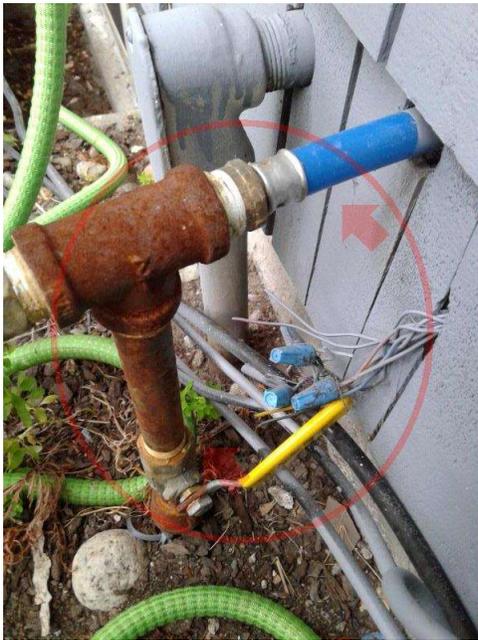
Addressed 12/18

MINOR REPAIR: The supply pipes are missing insulation at the front hosebib. This creates a potential condition for the water pipes to freeze and break. Recommend a licensed and bonded plumber make repairs to meet today's plumbing standards.

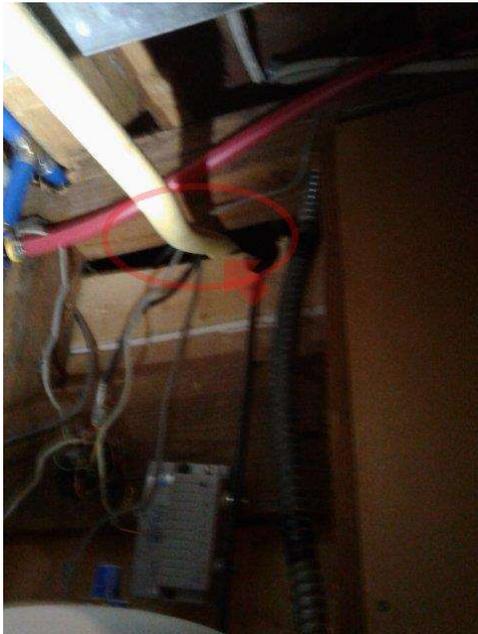
MINOR REPAIR: There is a flexible gas connector that enters through a concealed area. This is a gas leak safety hazard. Current accepted standards recommend that connectors shall not be concealed within, or extended through, walls, floors, partitions, ceilings or appliance housings. Recommend a licensed and bonded plumber make repairs to meet today's plumbing standards.

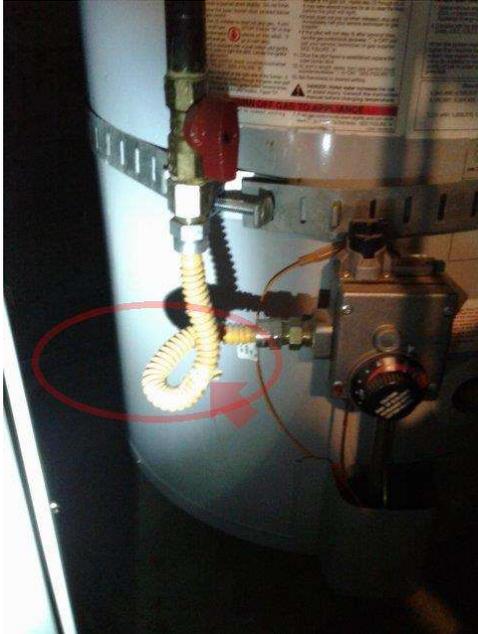
MINOR REPAIR: There is a crimped gas pipe. Pipe that is crimped may not allow full flow of gas as intended. Appliances that do not receive adequate gas supply may not function as intended, may be damaged, and may

produce carbon monoxide. The pipe may be weak at the crimp and subject to leaking. The sediment traps at gas equipment appear to be missing. A sediment trap helps remove debris in the gas flow that can damage gas appliances and cause inefficient or dangerous operation. Current accepted standards recommend that where a sediment trap is not incorporated as part of the gas utilization equipment, a sediment trap shall be installed downstream of the equipment shut-off valve as close to the inlet of the equipment as practical. Illuminating appliances, ranges, clothes dryers and outdoor grills need not be so equipped. The sediment trap is missing at the Furnace. The sediment trap is missing at the Water Heater. Recommend a licensed and bonded plumber make repairs to meet today's plumbing standards.

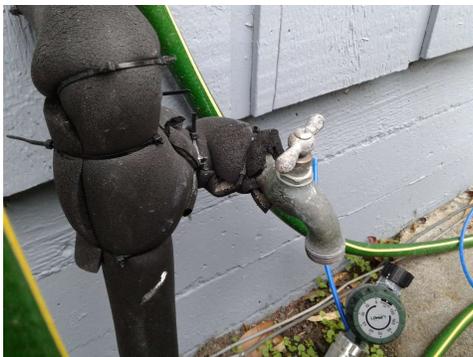
DEFERRED MAINTENANCE: The hosebibs do not have ant-siphon and frost proof devices. Recommend a licensed and bonded plumber upgrade to today's standards. The hosebib(s) requiring attention are: on the Back of the property. Recommend a licensed and bonded plumber make repairs to meet today's plumbing standards.

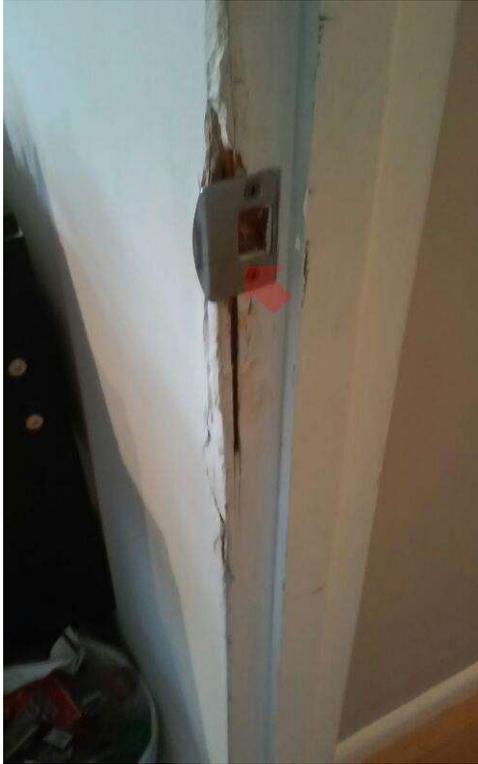
Addressed 12/18

MINOR REPAIR: Damage to door trim observed in west bedroom. Recommend a licensed and bonded contractor make repairs as needed to meet today's building standards.

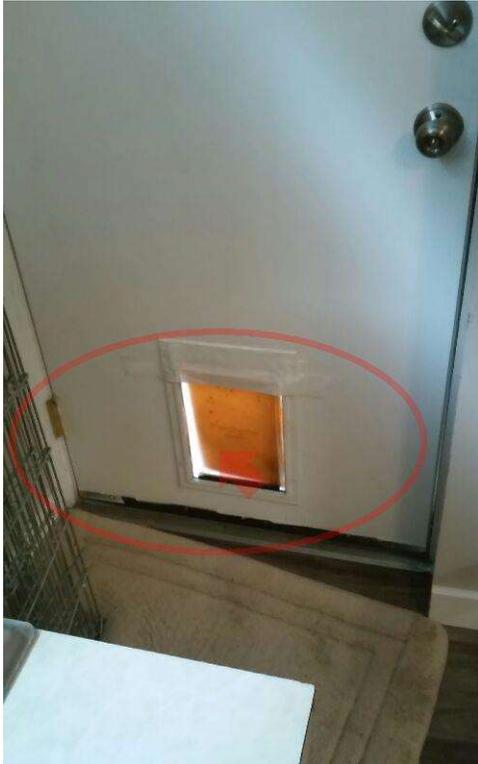
MINOR REPAIR: The inspector observed a pet door installed in the exterior door located in the: Basement. Recommend a licensed and bonded contractor make repairs as needed to meet today's building standards.

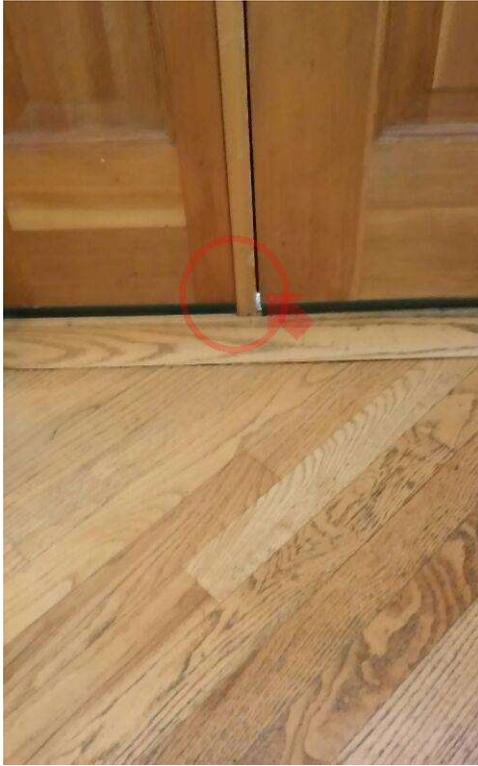
DEFERRED MAINTENANCE: Observed gap in weather stripping at base of main entrance door. Recommend a licensed and bonded contractor make repairs as needed to meet today's building standards.

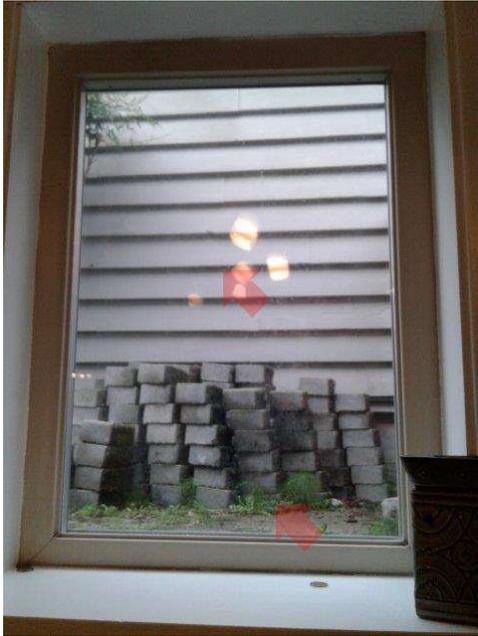
MINOR REPAIR: The double pane window seals appear to have failed. There is moisture between the panes of glass. Additional windows may have failed seals and may be more noticeable during changes in weather and/or humidity levels. Area of repair located in the: Basement Family Room, North side. Recommend a licensed and bonded contractor make repairs meets today's safety standards.

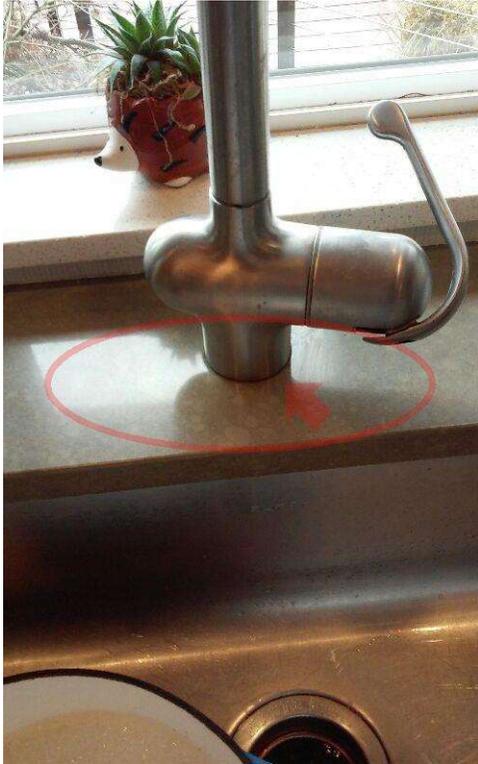
MINOR REPAIR: The fixture is loose. The sink fixture(s) requiring repair are located: Kitchen Recommend a licensed and bonded plumber make repairs to meet today's plumbing standards.

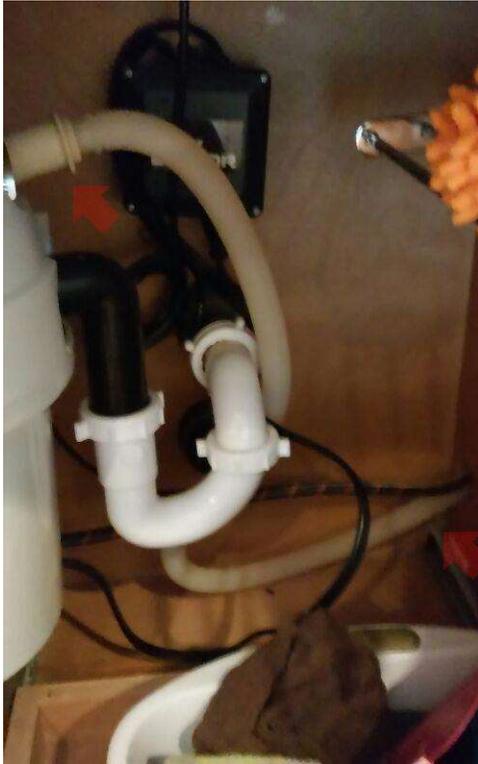
DEFERRED MAINTENANCE: We recommend installing or improving the air-gap device on the drain line, Recommend a licensed and bonded plumber make repairs to meet today's plumbing standards.

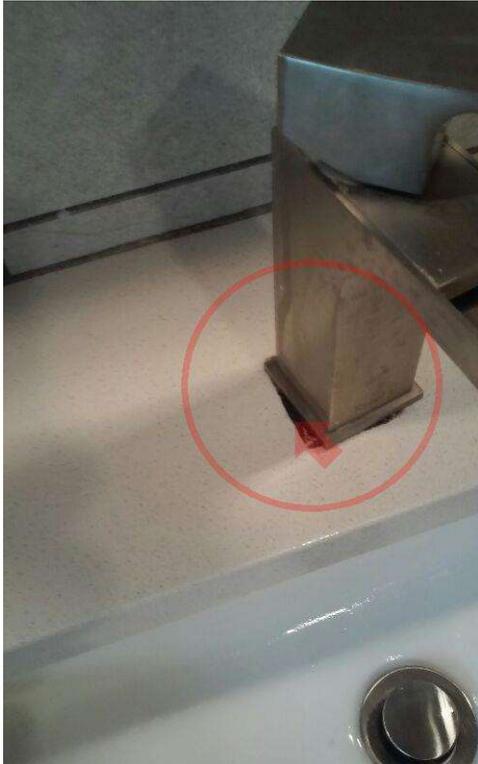
MINOR REPAIR: The fixture is loose. The sink fixture(s) requiring repair are located: Main Bathroom. Recommend a licensed and bonded plumber make repairs to meet today's plumbing standards.

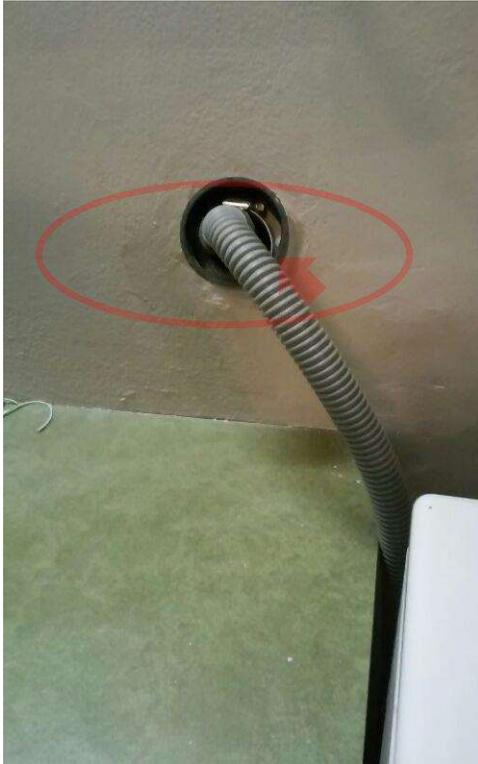
DEFERRED MAINTENANCE: Clothes washer discharge hose is unsecured, recommend securing as needed.

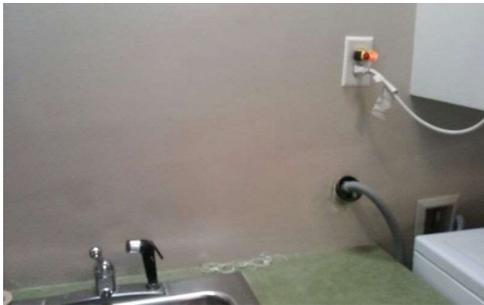
MINOR REPAIR: The electrical outlet(s) are not GFCI protected at: Laundry Room Sink. Recommend a licensed and bonded electrician make repairs to meet today's electrical safety standards.

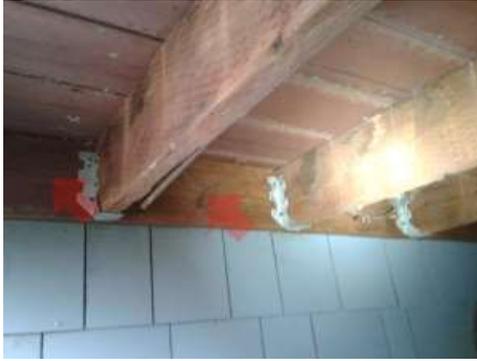
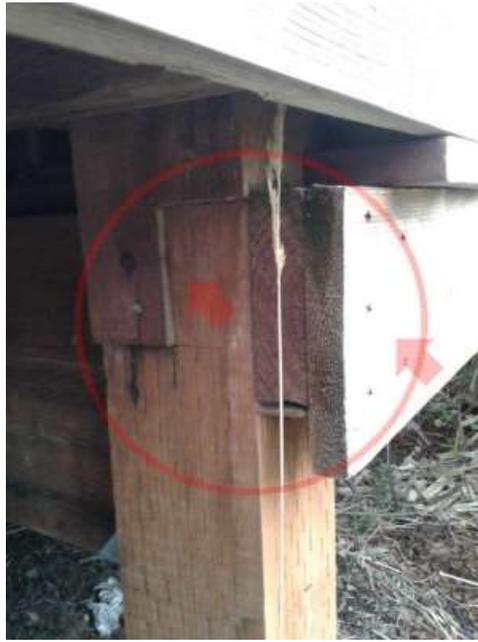
MINOR REPAIR: The deck ledger board is not attached with ledger bolts and washers. This type of construction method is not considered structurally sound by today's standards as the deck is not supported for lateral movements Recommend a licensed and bonded contractor make repairs to meet today's building standards.

MINOR REPAIR: The deck beam support to column connection on the North, outer side, does not meet today's building standards. The connection between the beam to band joist is screwed, not bolted. This creates a condition for the connection to pull apart under extreme lateral movements. Recommend a licensed and bonded contractor make repairs to meet today's building standards.

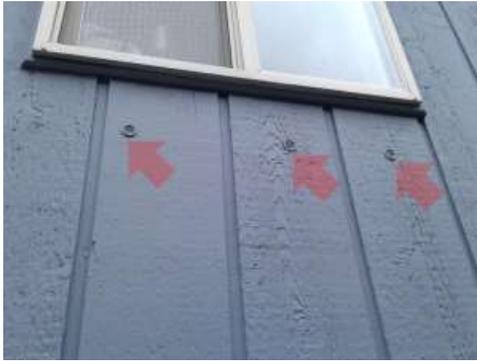
MINOR REPAIR: The walls appear to have had insulation added in the past, there are exterior penetrations are capped with vent covers. The exterior siding does not require ventilation and creates a condition for potential heat loss. Consider removing the vents and sealing the openings.

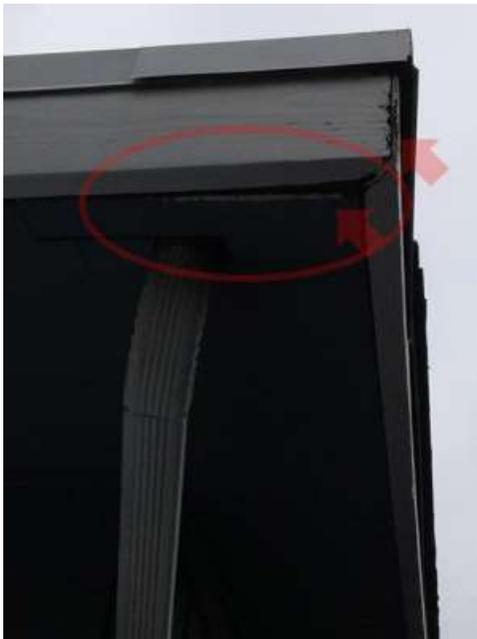
MINOR REPAIR: There are gaps in the soffits, fascia, trim, etc large enough for rodent entry. The area of repair is the NE corner of the house.

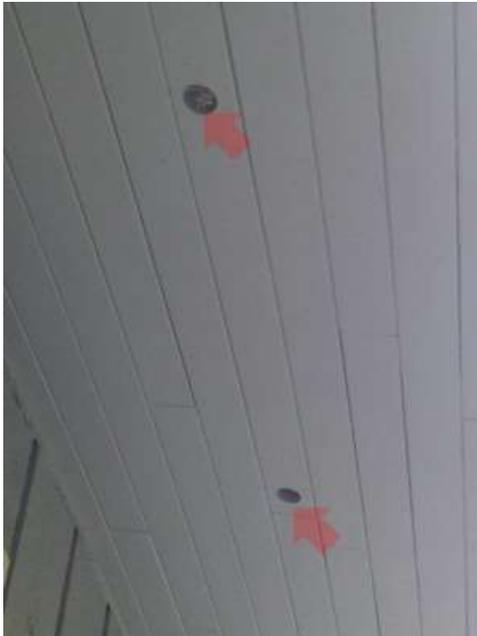
MINOR REPAIR: The soffit vent screens are loose and/or torn, this condition creates an access point for a potential rodent/bird infestation. Recommend a licensed and bonded contractor make repairs to meet today's building standards.

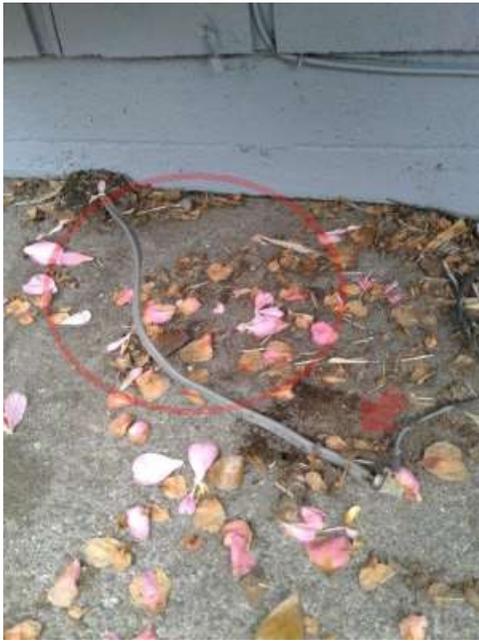
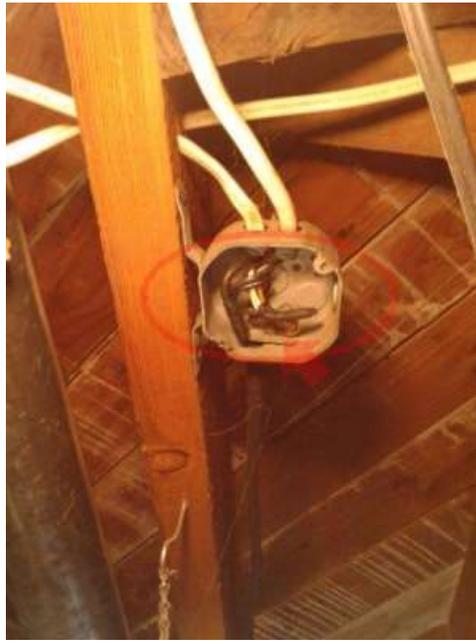
UPDATE TO TODAY'S STANDARDS: Portions of the electrical system are the original, cloth sheathed electrical wiring. These wiring systems are not grounded as is the standard for today's electrical wiring systems. Such systems may not meet the electrical demands of today's households. The number of electrical outlets in a room with this era of construction does not meet the number of outlets in more modern homes. Recommend further evaluation by a licensed and bonded electrician to assess the system's electrical ground.

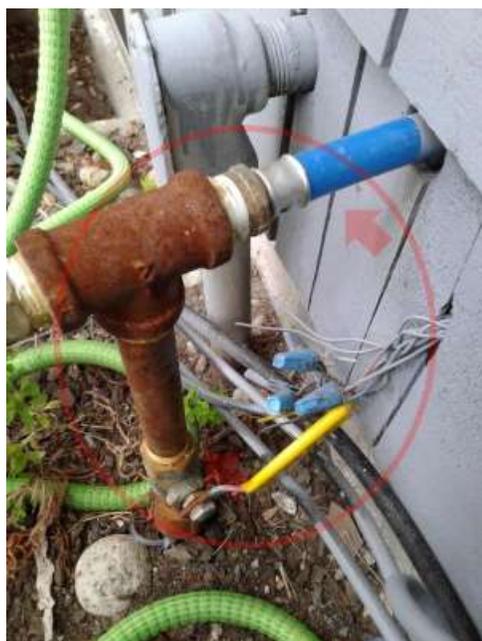
MINOR REPAIR: The supply pipes are missing insulation at the front hosebib. This creates a potential condition for the water pipes to freeze and break. Recommend a licensed and bonded plumber make repairs to meet today's plumbing standards.

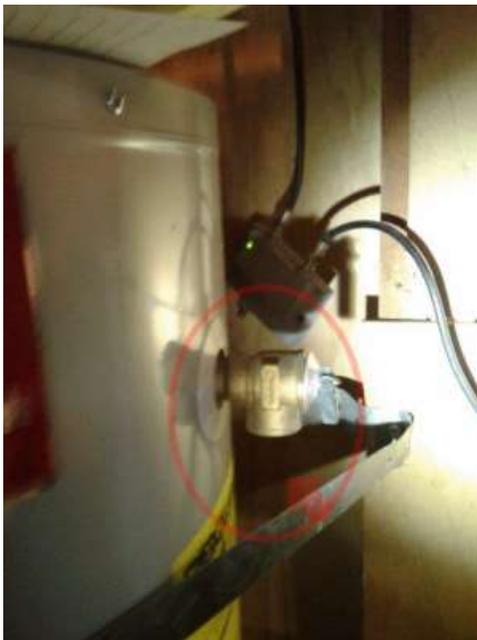
MINOR REPAIR: The TPR discharge pipe does not terminate properly. Current accepted standards recommend that the outlet of a temperature/pressure relief valve shall not be directly connected to the drainage system. The discharge from the relief valve shall be piped full size separately to the floor, to the outside of the building, or to an indirect waste receptor located inside the building. The discharge shall be installed in a manner that does not cause personal injury or property damage and that is readily observable by the building occupants. The discharge pipe shall be installed so as to drain by gravity flow and shall terminate atmospherically not more than 6 inches above the floor.

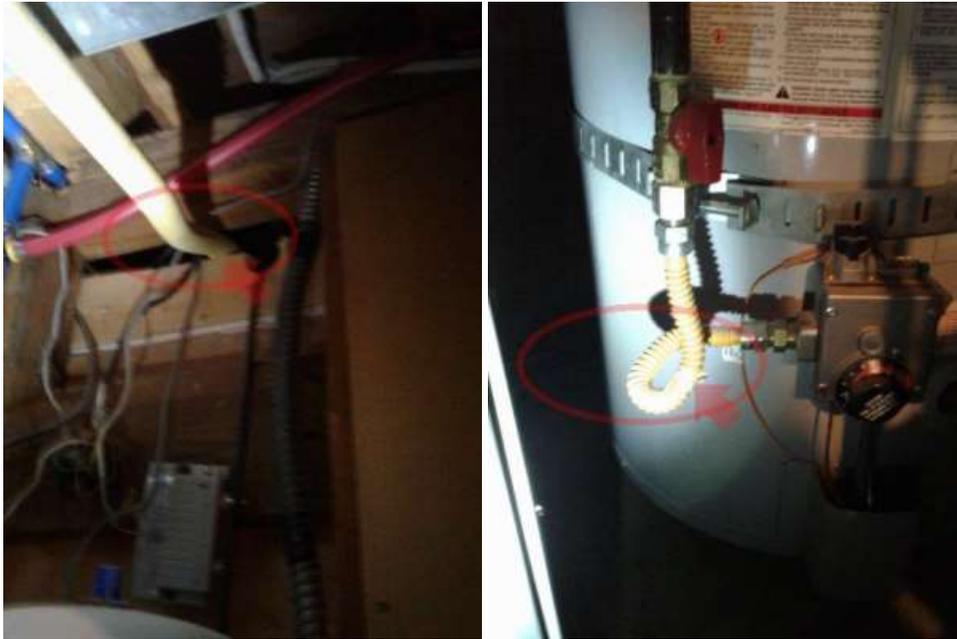
installed downstream of the equipment shut-off valve as close to the inlet of the equipment as practical. Illuminating appliances, ranges, clothes dryers and outdoor grills need not be so equipped. The sediment trap is missing at the Furnace. The sediment trap is missing at the Water Heater. Recommend a licensed and bonded plumber make repairs to meet today's plumbing standards.

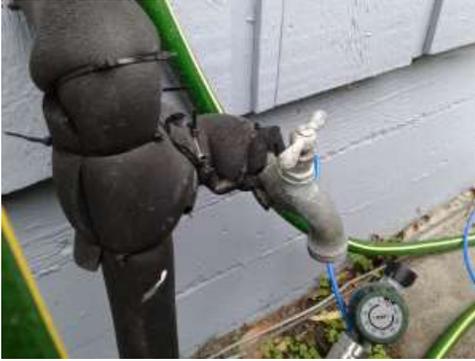
DEFERRED MAINTENANCE: The hosebibs do not have ant-siphon and frost proof devices. Recommend a licensed and bonded plumber upgrade to today's standards. The hosebib(s) requiring attention are: on the Back of the property. Recommend a licensed and bonded plumber make repairs to meet today's plumbing standards.

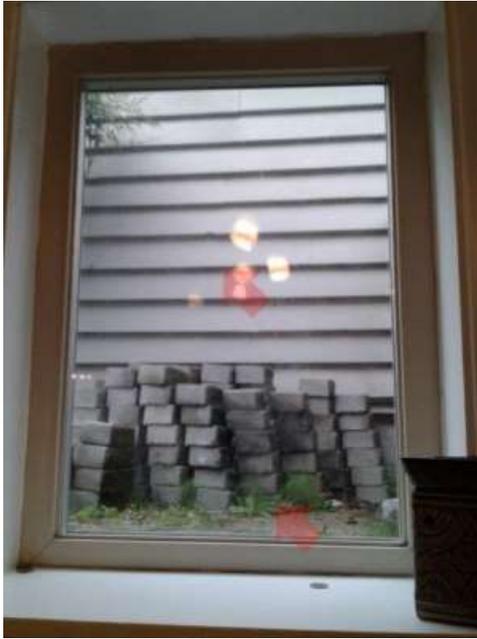
MINOR REPAIR: The double pane window seals appear to have failed. There is moisture between the panes of glass. Additional windows may have failed seals and may be more noticeable during changes in weather and/or humidity levels. Area of repair located in the: Basement Family Room, North side. Recommend a licensed and bonded contractor make repairs meets today's safety standards.

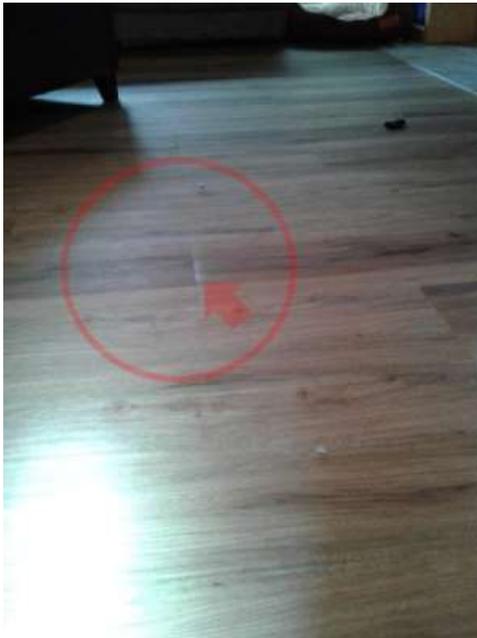
There is minor buckling to the laminate floor in the center of the basement family room. The buckling is minor and considered a cosmetic flaw

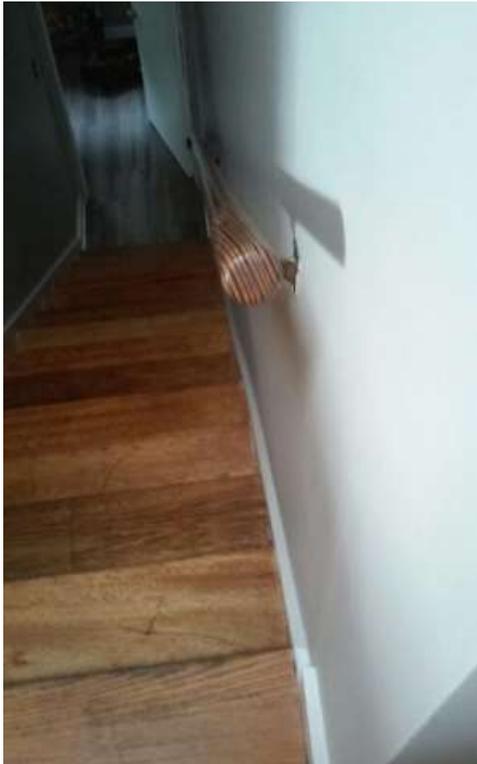
MINOR REPAIR: Improvement needed to stairs and/or handrail(s) A missing handrail return was observed, creating a potential safety hazard. Recommend a licensed and bonded contractor make repairs as needed to meet today's building standards.

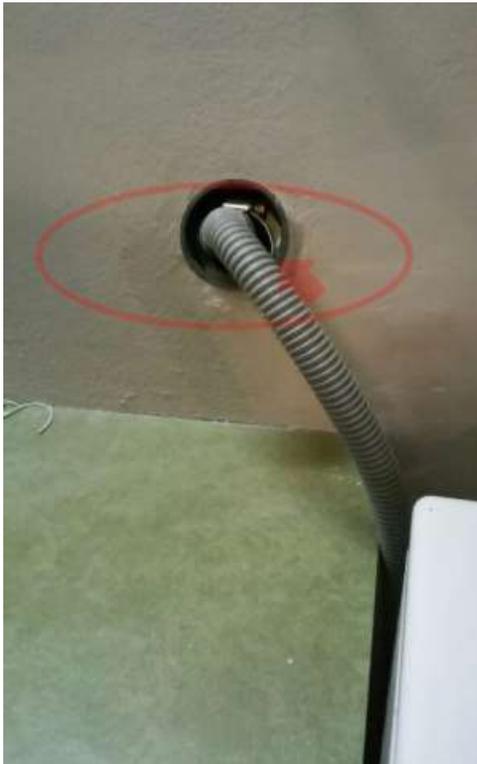
Hose Bibs / Hookups/Washer Stand Pipe:
DEFERRED MAINTENANCE: Clothes washer discharge hose is unsecured, recommend securing as needed.
