Sewer Scope Inspection Report

NAME: Samantha Li	EMAIL: smanthali007@gmail.com	DATE: December 11, 2023
PO: MS-370-23	BUILDING AGE: 84 years	BUILDING STYLE: Single Family Residence
ADDRESS: 2446 S 116th St Seattle, WA 98168	ATTENDEES: Owner	WEATHER: Rain
REALTOR: Sarah Georger Clark	EMAIL: sarahgc@cloudcityhomes.com	INSPECTION TYPE: Sewer
INSPECTION BUNDLE: Inspection and Report

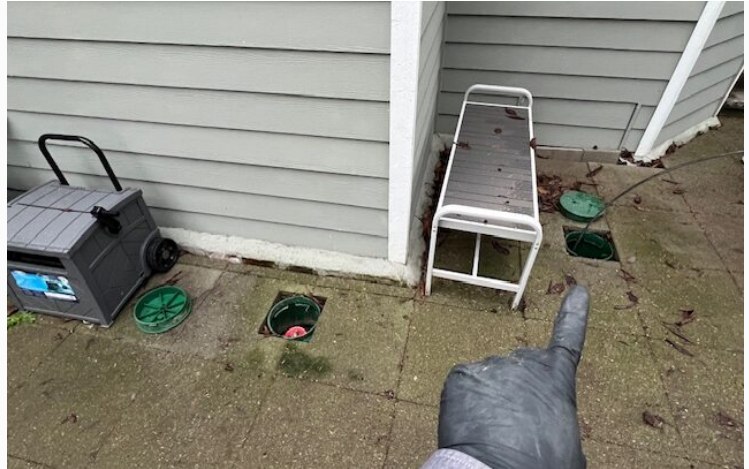
Sewer Access #1

TYPE: Exterior One Way Cleanout

MATERIALS: PVC

SURFACE MATERIAL: Concrete Paver

CONDITIONS: Appears Functional

RECOMMENDATIONS: No recommended maintenance, repair or replacement at this time.

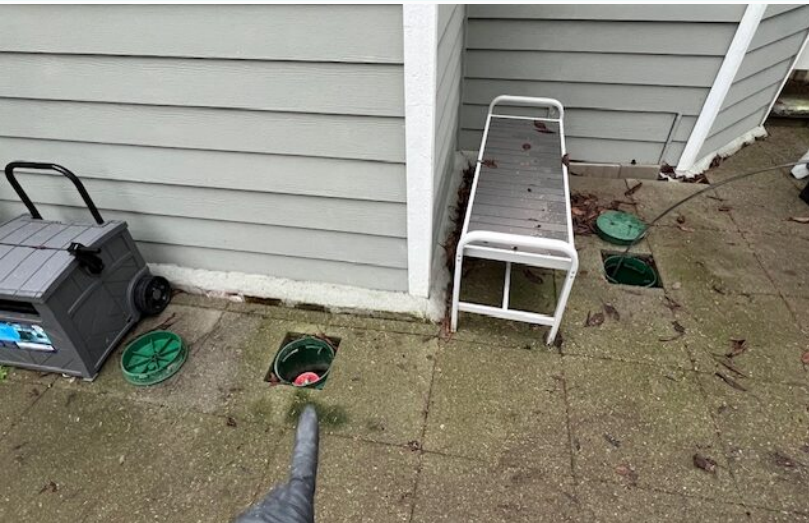
Sewer Access #2

BURIED: No

TYPE: Exterior One Way Cleanout

MATERIALS: PVC

SURFACE MATERIAL: Concrete Paver

CONDITIONS: Appears Functional

DISTANCE TO ADDITIONAL CLEAN OUT: 7'

RECOMMENDATIONS: No recommended maintenance, repair or replacement at this time.

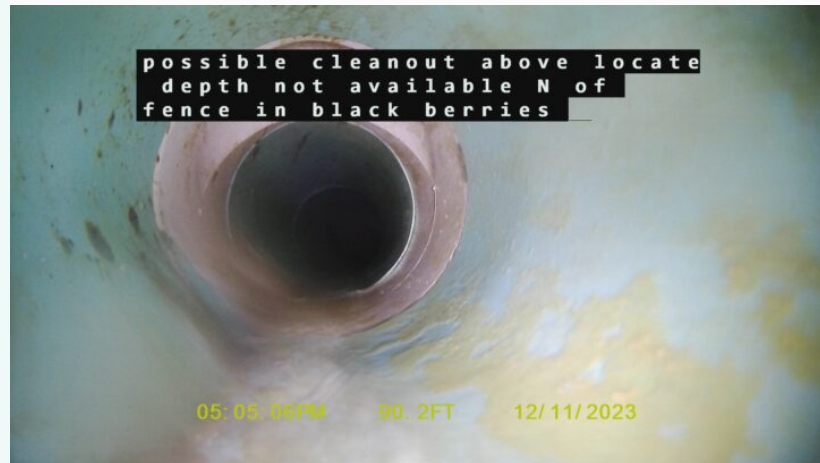
Potential Access #3

BURIED: Yes

TYPE: Exterior One Way Cleanout

MATERIALS: PVC

SURFACE MATERIAL: Blackberries

CONDITIONS: Buried

DISTANCE TO ADDITIONAL CLEAN OUT: 90'

RECOMMENDATIONS: No recommended maintenance, repair or replacement at this time.

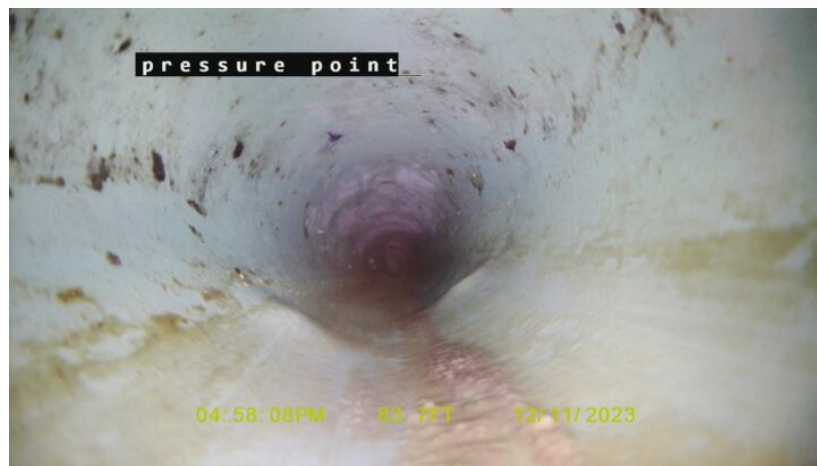
Condition #1

CONDITION: Pressure Point		PIPE MATERIALS: PVC	
DISTANCE TO CONDITION FROM ENTRY POINT: 78 and 84'		CONDITION DEPTH: Unknown	
CONDITION LOCATION: Right Of Way		CONDITION LOCATION SURFACE MATERIAL: Blackberries	
MARKER: None			
RECOMMENDATIONS: No recommended maintenance, repair or replacement at this time.

RETURN FREQUENCY: (3 to 5 years) Conduct a return inspection in 3 to 5 years to observe significant changes in the condition items listed in the condition portion of this inspection report.

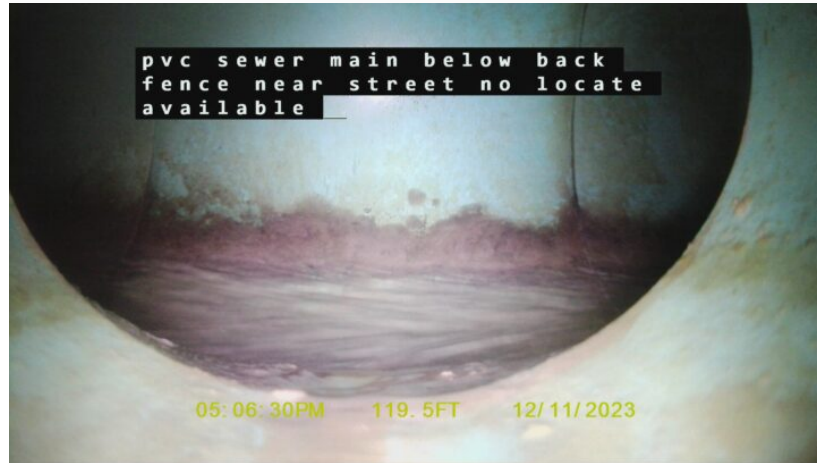
Sewer Main

CONNECTION MATERIAL:	PVC	CONNECTION LOCATION:	Right Of Way
CONNECTION LOCATION SURFACE MATERIAL:	Grass	DEPTH:	Unknown
CONNECTION CONDITION:	None	MARKER:	None

RECOMMENDATIONS: No recommended maintenance repair or replacement at this time.

RETURN INSPECTION FREQUENCY: Conduct a return inspection after the appropriate maintenance has been completed and the pipe is clear to observe all areas for visible damage and/or to confirm functionality.
