Sewer Scope Inspection Report

NAME: Shauna Iseri	EMAIL: shaunaiseri@gmail.com	PHONE: (208) 985-8262
DATE: March 9, 2024	PO: RL-332-24	BUILDING AGE: 99 years
BUILDING STYLE: Single Family Residence	ADDRESS: 7236 Ledroit Ct SW Seattle, WA 98136	ATTENDEES: Agent, Inspector
WEATHER: Overcast	REALTOR: Sarah Georger Clark	EMAIL: Sarahgc@cloudcityhomes.com
INSPECTION TYPE: Sewer	INSPECTION BUNDLE: Inspection and Report

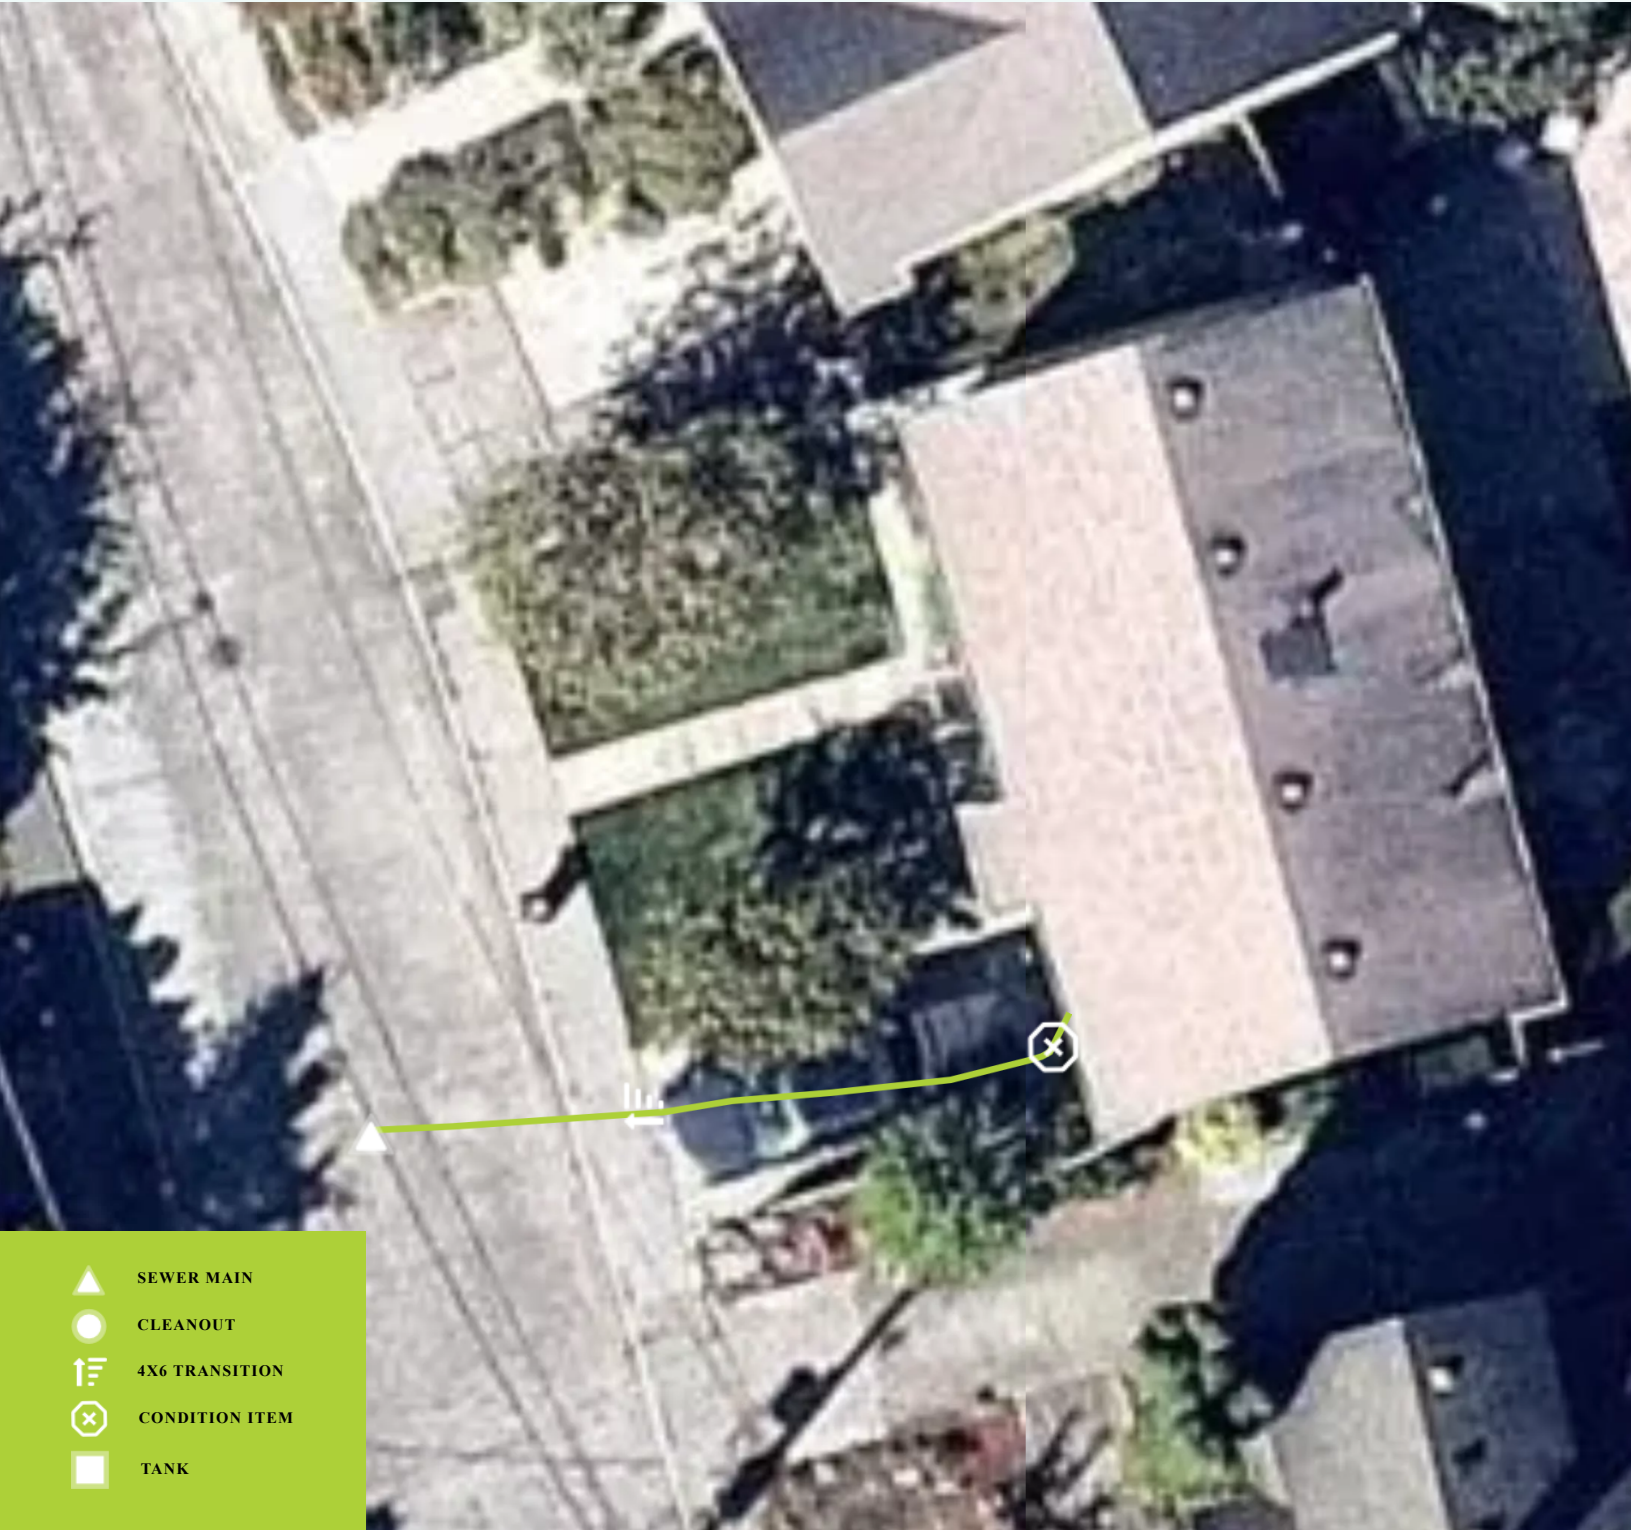
Sewer Line Map

CONDITION: Offset

**DISTANCE TO
CONDITION FROM
ENTRY POINT:** 1' from
garage
door

**CONDITION
LOCATION:** Driveway

RECOMMENDATIONS: Recommend monitoring of the condition item/s through a follow up inspection to identify significant changes in the condition items observed during the side sewer inspection.
