Report: 3213 - 3950 se arroyo dr seattle

Confidential Inspection Report

3950 SE Arroyo DR

November 6, 2018

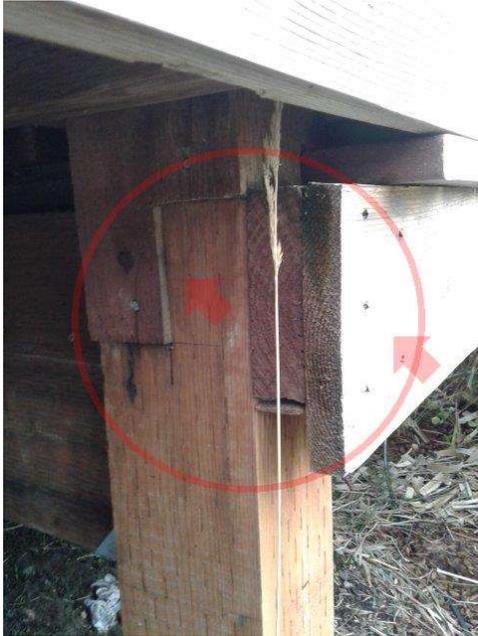
MINOR REPAIR: The deck beam support to column connection on the North, outer side, does not meet today's building standards. The connection between the beam to band joist is screwed, not bolted. This creates a condition for the connection to pull apart under extreme lateral movements. Recommend a licensed and bonded contractor make repairs to meet today's building standards.

Cleaned by Seller 12/18

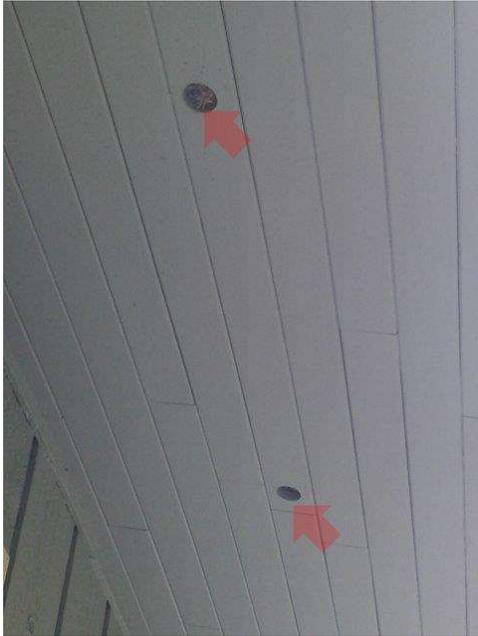
MINOR REPAIR: The soffit vent screens are loose and/or torn, this condition creates an access point for a potential rodent/bird infestation. Recommend a licensed and bonded contractor make repairs to meet today's building standards.

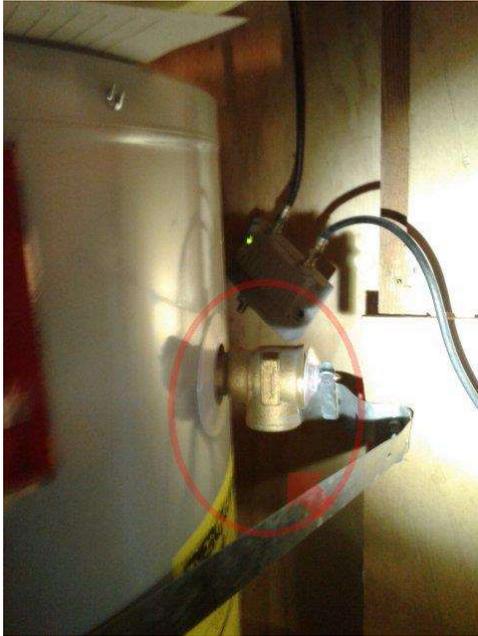
MINOR REPAIR: The TPR discharge pipe does not terminate properly. Current accepted standards recommend that the outlet of a temperature/pressure relief valve shall not be directly connected to the drainage system. The discharge from the relief valve shall be piped full size separately to the floor, to the outside of the building, or to an indirect waste receptor located inside the building. The discharge shall be installed in a manner that does not cause personal injury or property damage and that is readily observable by the building occupants. The discharge pipe shall be installed so as to drain by gravity flow and shall terminate atmospherically not more than 6 inches above the floor.

Addressed 12/18

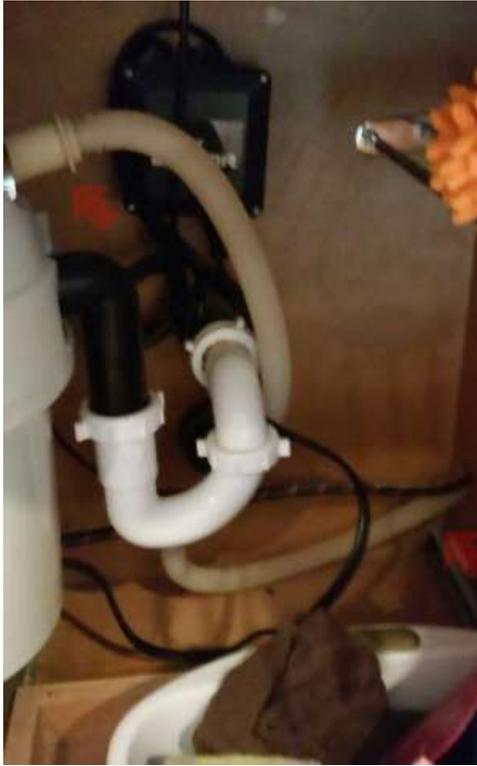
MINOR REPAIR: Unit makes unusual noises, the unit appears at or approaching the end of its useful life.

Recommend a licensed and bonded electrician make repairs as needed to meet today's electrical standards.

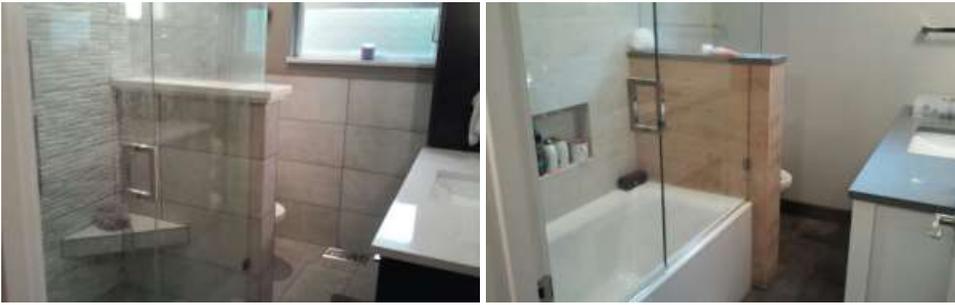
MINOR REPAIR: The fixture is loose. The sink fixture(s) requiring repair are located: Main Bathroom. Recommend a licensed and bonded plumber make repairs to meet today's plumbing standards.
