Sewer Scope Inspection Report

NAME: Samantha Li	EMAIL: smanthali007@gmail.com	DATE: December 11, 2023
PO: MS-370-23	BUILDING AGE: 84 years	BUILDING STYLE: Single Family Residence
ADDRESS: 2446 S 116th St Seattle, WA 98168	ATTENDEES: Owner	WEATHER: Rain
REALTOR: Sarah Georger Clark	EMAIL: sarahgc@cloudcityhomes.com	INSPECTION TYPE: Sewer
INSPECTION BUNDLE: Inspection and Report

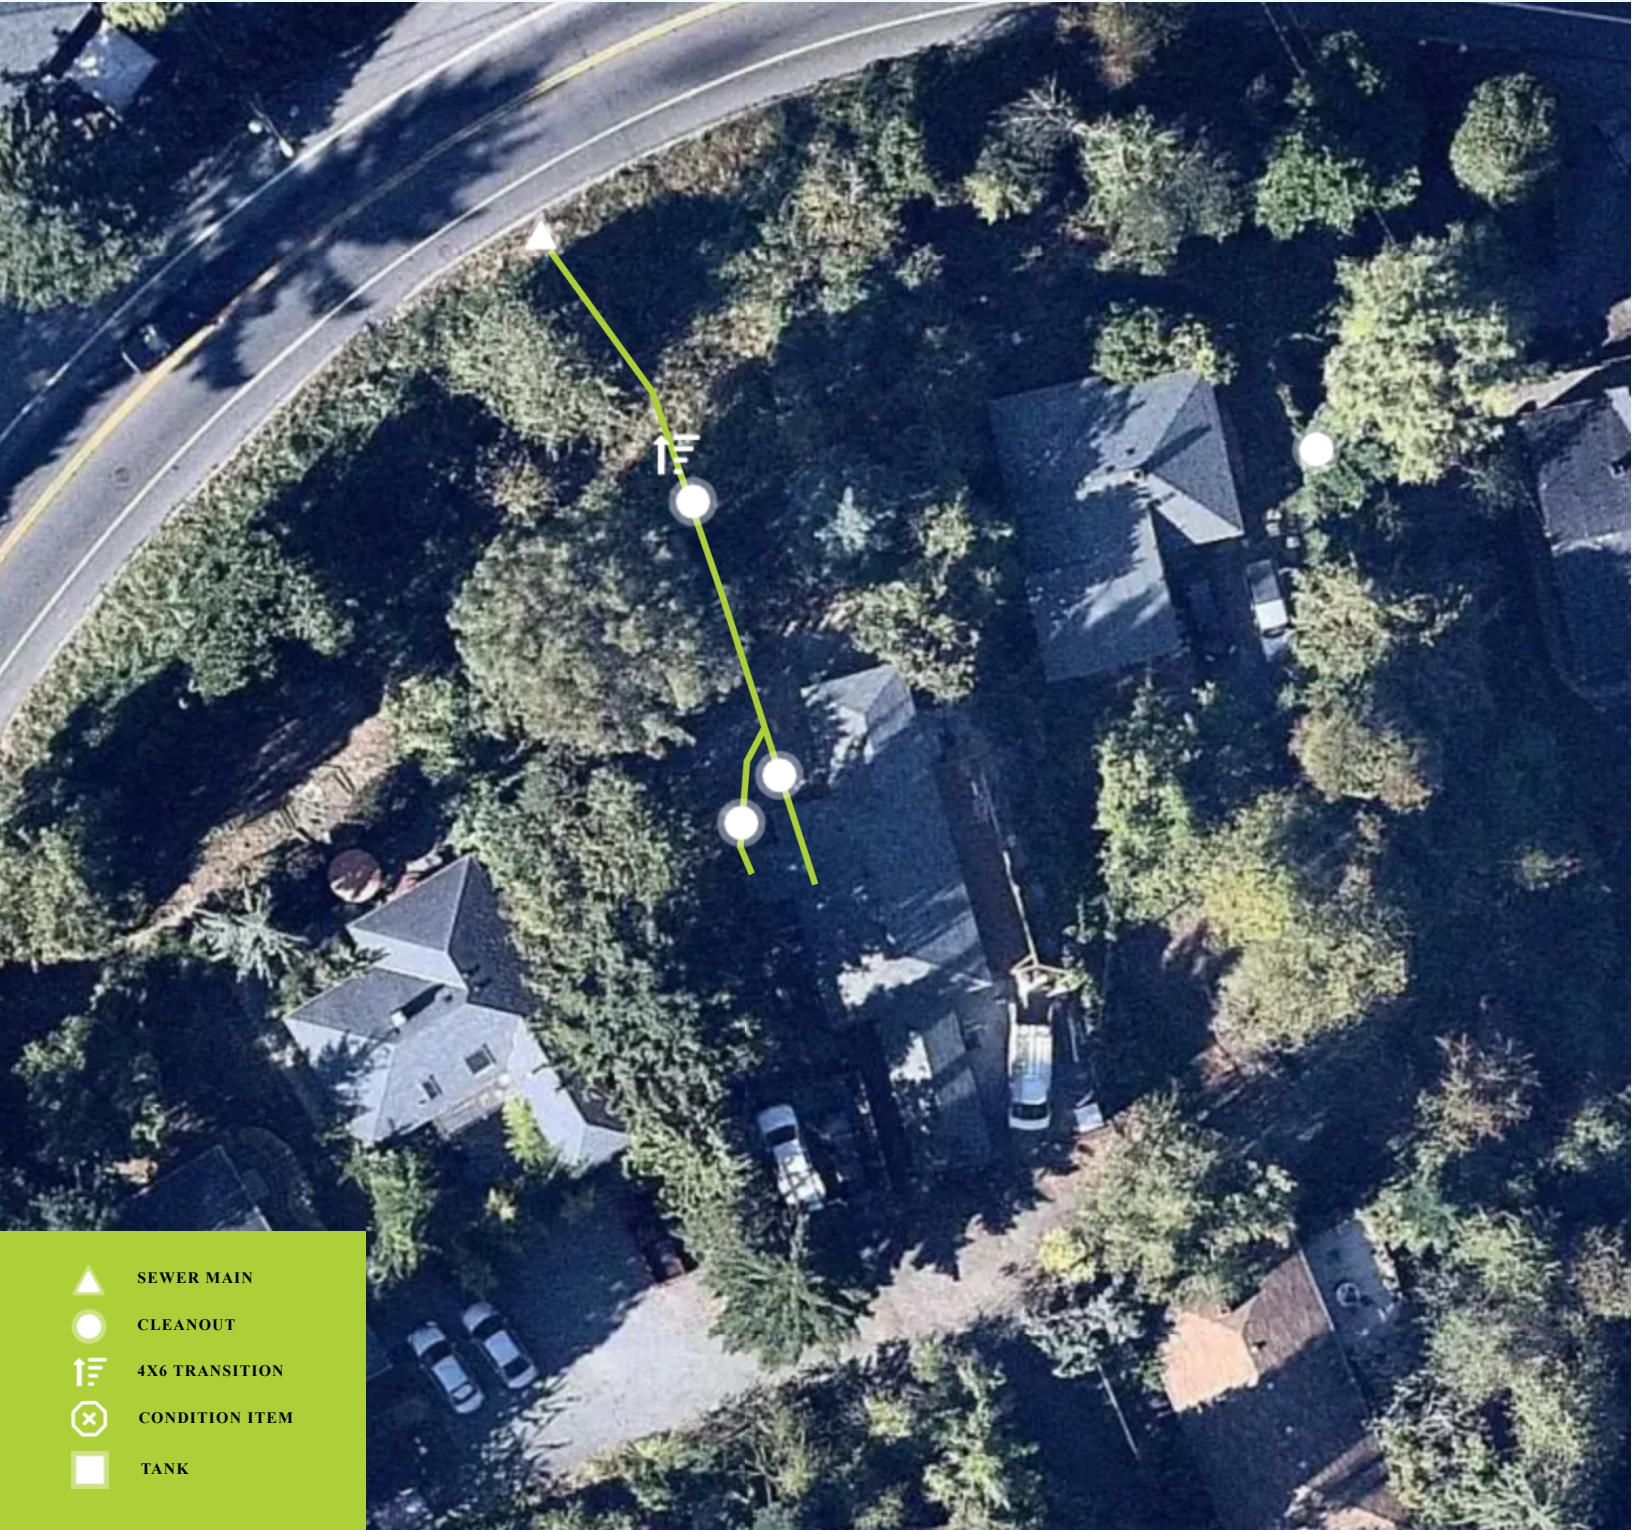
Sewer Line Map

CONDITION: Pressure Point		PIPE MATERIALS: PVC	
DISTANCE TO CONDITION FROM ENTRY POINT: 78 and 84'		CONDITION DEPTH: Unknown	
CONDITION LOCATION: Right Of Way		CONDITION LOCATION SURFACE MATERIAL: Blackberries	
MARKER: None			
RECOMMENDATIONS: No recommended maintenance, repair or replacement at this time.
